## Case Study BASEMENT WATERPROOFING - CHISWICK

### RUSSIAN ORTHODOX CHURCH

**New Build Waterproofing Project: Failed tanking to prestigious project solved with Newton Waterproofing Systems.**

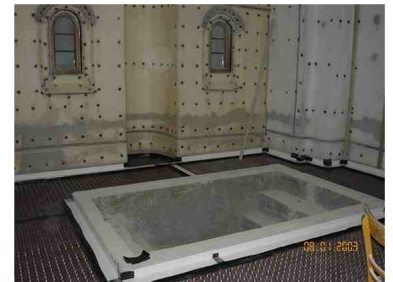
All Newton membrane products were installed within this complex waterproofing project.

As is often the case, Newton System 500 was specified as the remedial system to put right the failed tanking. Because the Church is constructed in structural concrete, it was decided to sit the Newton Basedrain perimeter drainage channel above the concrete raft rather than form a recess within it. Newton 500 and Newton 500 Lath was fitted to all retaining walls to ensure that any water seepage at the walls would be diverted to the Basedrain, and because the consistency of the concrete raft was in doubt, Newton 520 flooring membrane was laid to the floor to divert any water that may arrive through inconsistencies within the raft to the Newton Basedrain. Because the Newton 520 was laid on the raft adjacent to the Basedrain it cannot be used a vapour / DPM flooring membrane also, as would be the case if the floor membrane was laid above the top of the Basedrain. The Newton 520 was in fact a 'lost' drainage layer whose sole purpose is to prevent local points of water pressure occurring if, as was suspected, the raft was in such a poor condition that water should pass through non-designed cracks within the concrete.

The cavity drain membrane system was used to control the water ingress from the many points of leakage in the structure rather than try to 'plug' each incidence of leakage or to line the property with a tanking membrane. The design team felt that the drained system had a much better chance of success

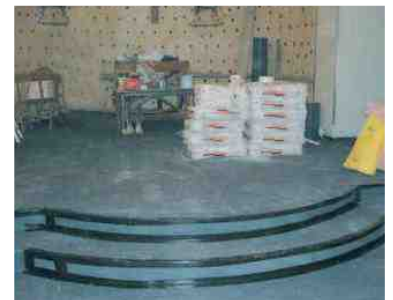
Newton Slimline Flooring installed over damp RC slab.

A 'closed cell' insulation was laid above the Newton 520 and Newton Slimline Flooring was laid above the insulation and sealed to the Newton 500 on the walls to form the vapour barrier / DPM. The floor was finished with a sand/cement screed to the original finished floor level, and the walls were finished with dry-lining over the Newton 500 and a sand & cement render to the Newton 500 Lath. All wall surfaces were then skimmed. Also interesting is the fact that virtually all of Newton product range was used on this one project.

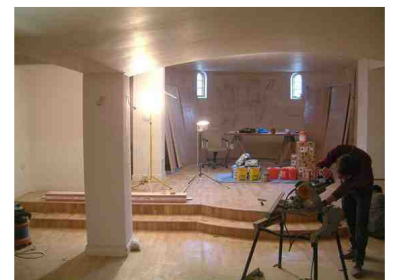
Moisture sensitive flooring installed over Slimline Floor membrane.
